**SAS Superstructure**

Daily Diary Report by Bid Item

Contract No.: 04-0120F4

Diary #: 470 Const Calendar Day: 848 Date: 04-Jan-2012 Wednesday

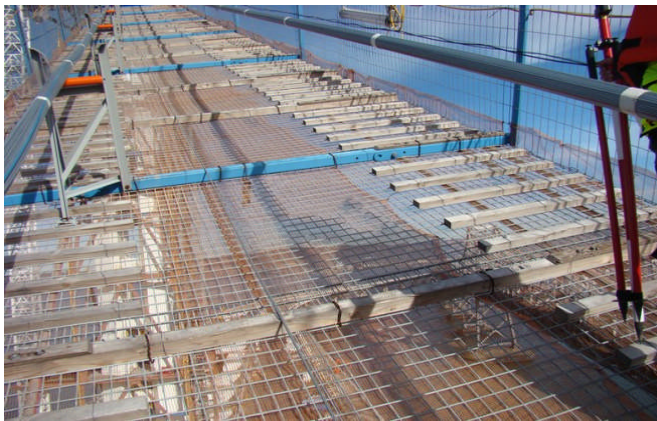
Surveying the south backspan catwalk to determine the distance of cable strand #1 in relation with the catwalk.

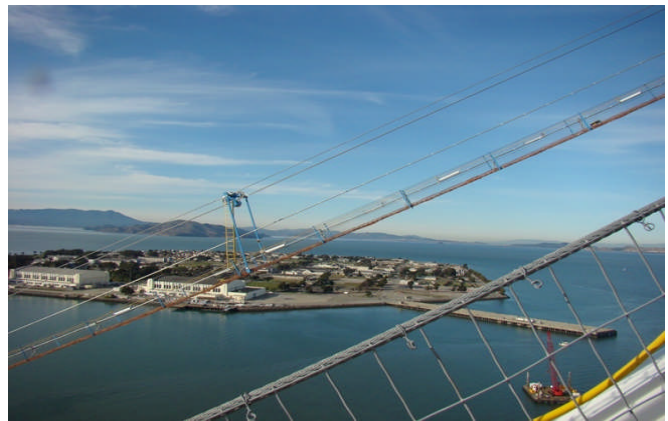
View of north backspan elevation difference between cable strand #1 and the catwalk.

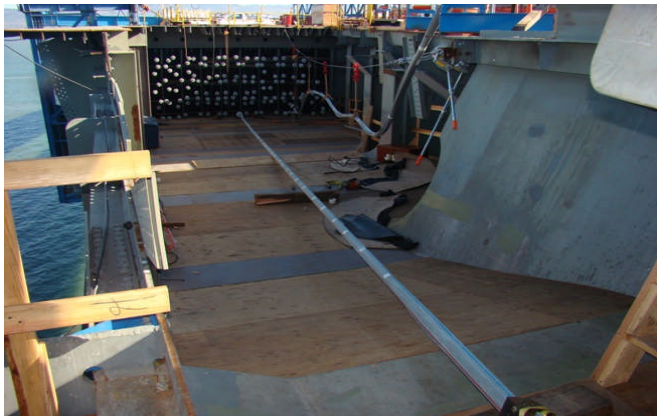
The W-Line east end socket for cable strand #1 was connected to the anchor rod in OBG lift 14W.

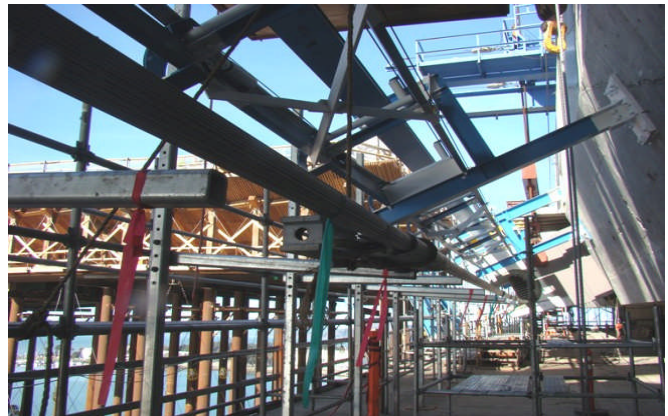
Cable strand #1 sag adjustment system at the south section of the west loop.

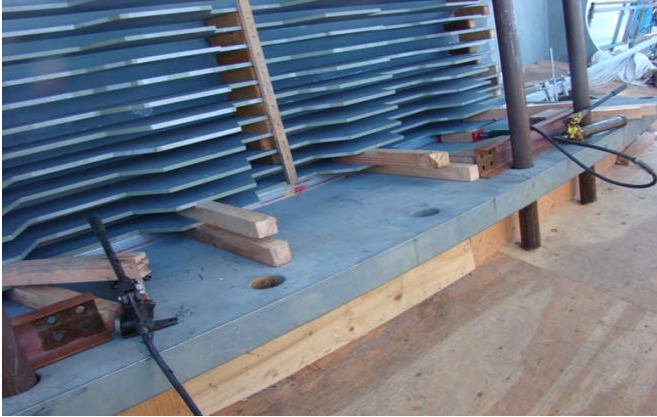
Cable strand #1 placed into the W-Line east saddle trough, a step closer to surveying cable strand #1 in the free hanging position.

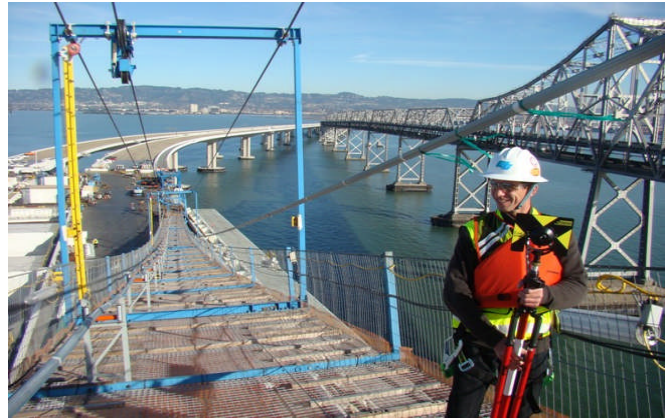
Surveying the south mainspan catwalk to determine the distance of cable strand #1 in relation with the catwalk.

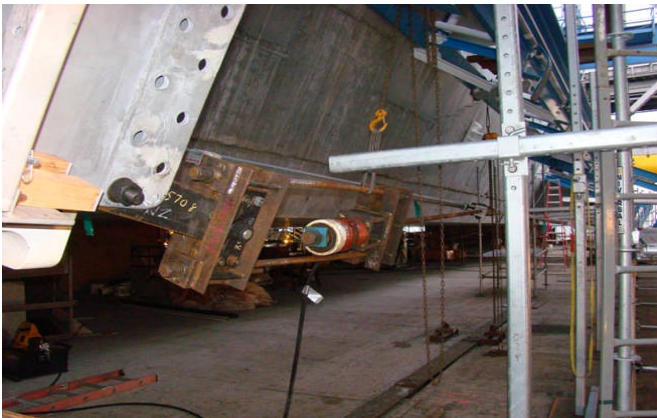
Cable strand adjuster jacking assembly for the W2W west deviation saddle.

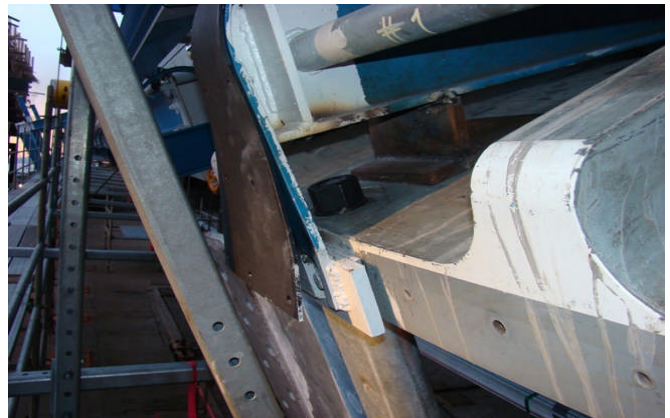
Modifications made to the secondary hauling framework support to install the cable strand adjuster threaded rod.
